# RAPID TERRAIN ANALYSIS IN LANDSLIDE ZONES: GPR AND AIRBORNE PHOTOGRAMMETRY AS A COMPLEMENT FOR THE LEVELLING DATA. CASE STUDY NEAR POIANA RUSCĂ DAM, ROMANIA

**Abstract.** This paper investigates rapid terrain analysis in landslide-prone areas, emphasising a case study near the Poiana Ruscă Dam, Romania. The research integrates Ground Penetrating Radar (GPR) and airborne photogrammetry, complemented by traditional levelling data, to assess a known landslide with small dimensions on the southwest side of the Poiana Ruscă Lake, near the dam's upstream side. This landslide is part of an annual topo-geodetical monitoring campaign due to its potential impact on the dam's stability. The study utilises a compact drone to generate orthophotomosaics and Digital Elevation Models (DEMs) for the road sections above the landslide, identified in topo-geodetical records. This method offers high-resolution surface deformation data, providing a clear view of the impact on the affected road. The GPR method, employing a 200 MHz antenna, plays a crucial role in revealing subsurface details, particularly in areas where traditional levelling surveys face challenges due to disappearing benchmarks cause

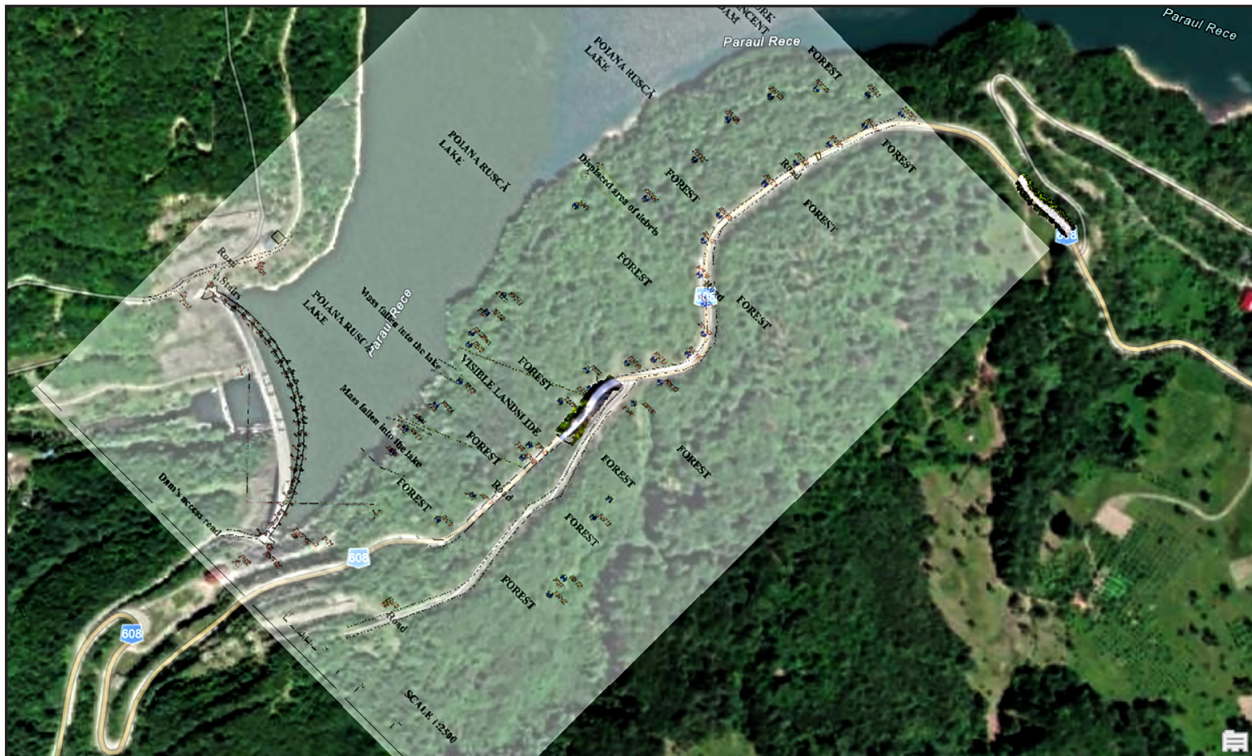
**Fig. 3.** Overview from ArcGIS representing the overlapping of the topo-geodetic network plan with the airborne photogrammetry surveys.

The areas chosen for the airborne surveys (Fig. 3) was as follows: one corresponding to the landslide area marked in the levelling network plan, where the road was visibly damaged at the surface; the second one is outside the levelling network on the same DJ608 road more to the east, in an area also clearly affected by land movements visible in the abundant cracks in the road.

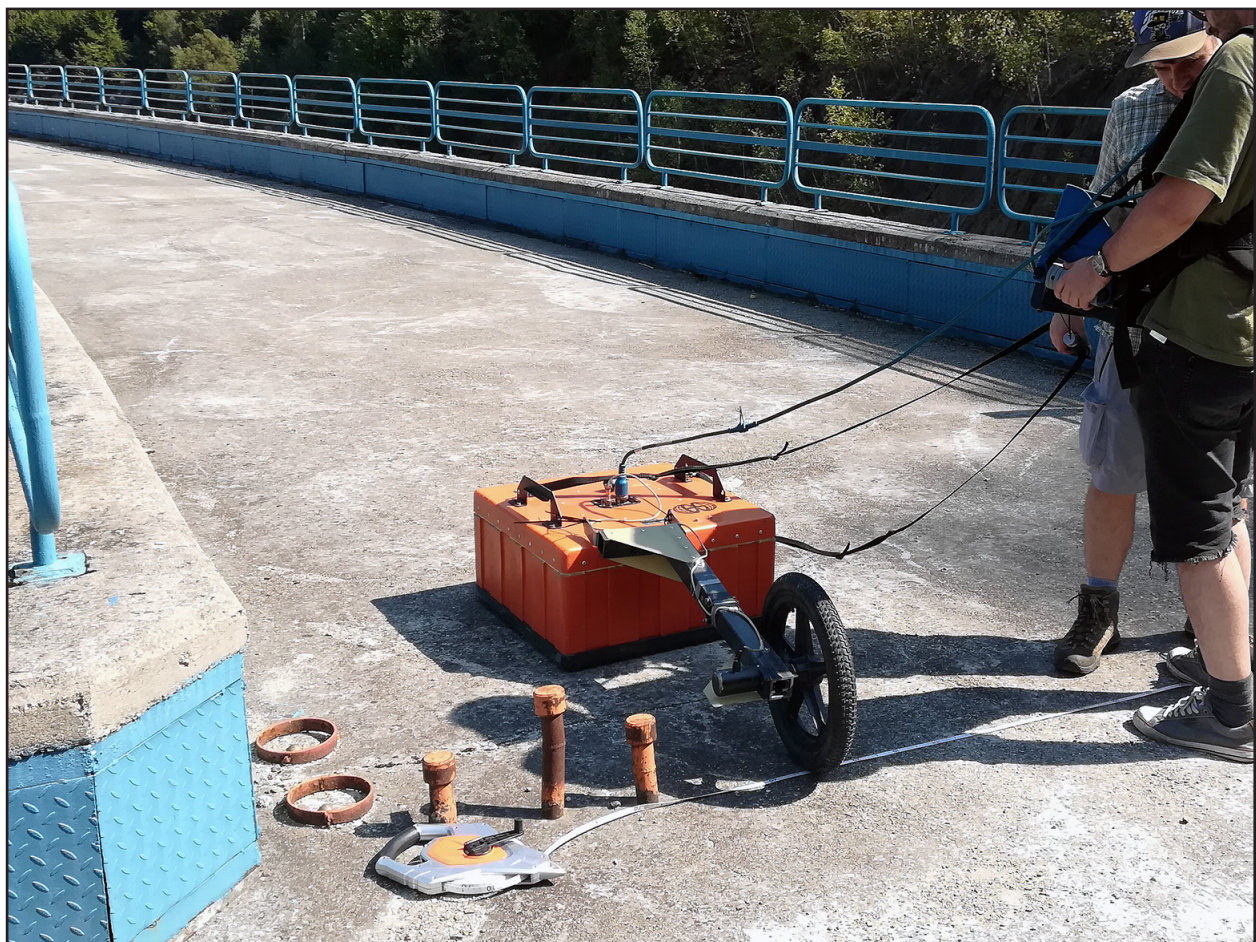
**Fig. 4.** The GPR equipment, formed of one 200 MHz antenna, a wheel for measuring distances and the GSSI-SIR 3000 console.

At the surveys from the left slope adjacent to the Poiana Ruscă dam, a GSSI SIR-3000 with a 200 MHz (Fig. 4) antenna was employed. Despite the equipment's versatility, careful parameter selection is key for effective data acquisition. This antenna frequency was chosen with the purpose of collecting data from deeper layers and to manage to characterise the subsurface structure and find potential causes of the deformations and deteriorations on the road on which the surveys were carried out. A number of 10 profiles at a distance of 0.5m in between were carried out in the direction of the road, with profiles starting from the upper side of the slope and moving towards the lower side of the slope (towards the lake).

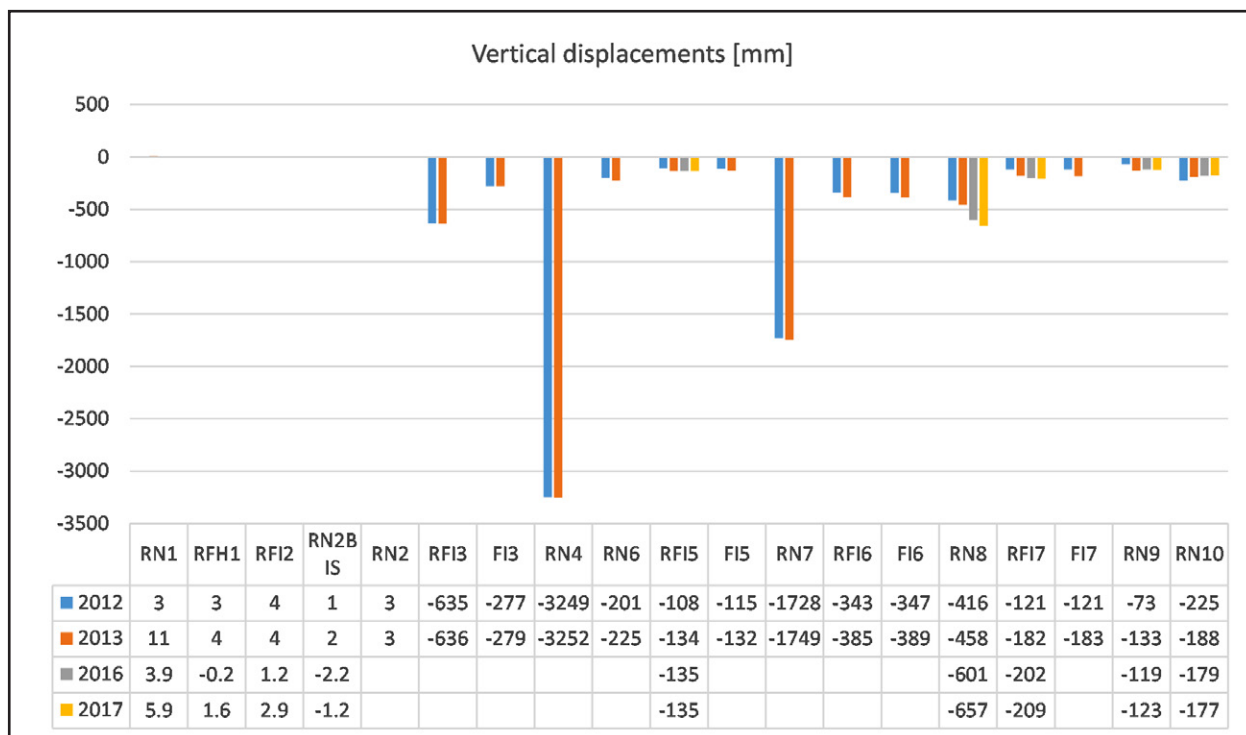
**Fig. 5.** Vertical displacements at the first half of the marks resulted from the levelling surveys. Missing data corresponds to the missing of the actual marks in the field throughout the years.

In terms of levelling data and information these are represented in terms of elevation differences compared to preset 0 elevation (Figs. 5-6). The data has been split in two graphs for better visualisation and to mark two areas - the one on the west side - closer to the dam and affected by the visible landslide, and the second one to the east, furthest away from the dam along the road. The marks which suffered damage or couldn't be found in the field were removed altogether from the graphs. For example RN3 benchmark (Fig. 2) due to its position in the fallen mass in the lake in the area of the visible landslide, this was not found and data is not available for it since 2012. Other benchmarks which suffered similar problems are the combination of benchmarks and fixed marks, RN5, RF14 and F14 which are placed in the large mass fallen into the lake area, closer to the dam.

In the first set of data (Fig. 5) there appear to be more benchmarks which haven't been surveyed in the past campaigns due to their damages. Most of the remaining benchmarks show small variations, however there are two benchmarks, RN4 and RN7 which appear to have the highest variation by comparison with all the other benchmarks, and these are found inside the area marked as active landslide which is already known.

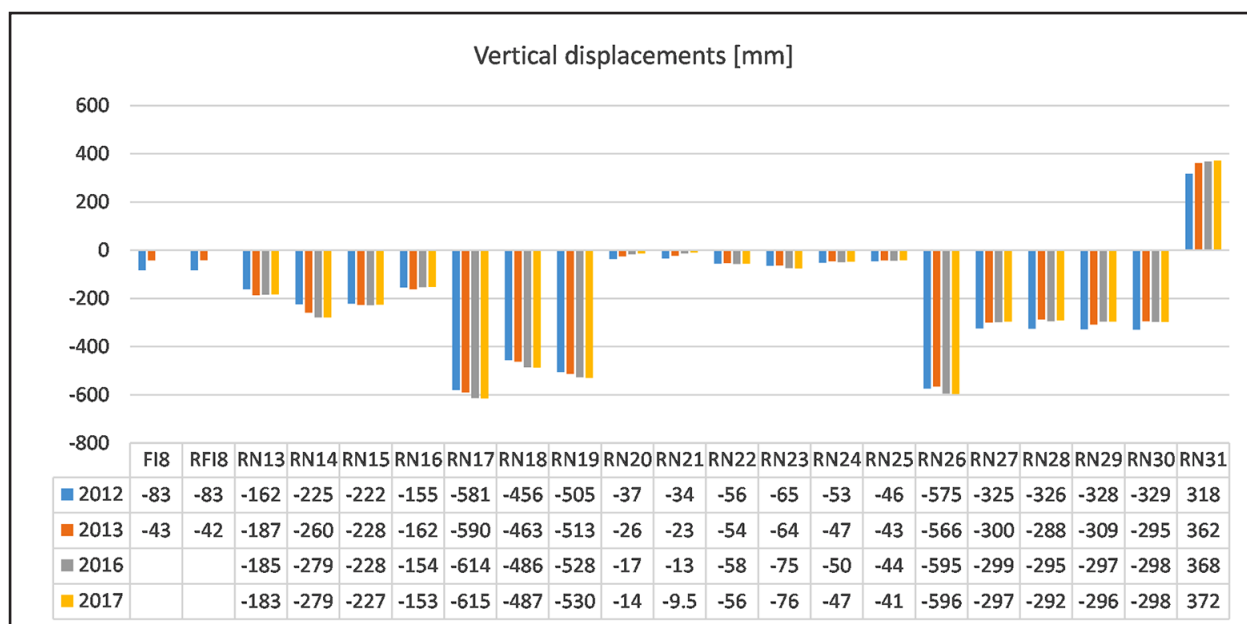
**Fig. 6.** Vertical displacements at the second half of the marks resulted from the levelling surveys. Missing data corresponds to the missing of the actual marks in the field throughout the years.

In the eastern part of the survey area, the data along the road towards the opposite side compared to the position of the dam, all of the benchmarks seem to still be in the right place, bench marks RN 13-31 (Fig. 2). At least from this point of view, this area appears to be more stable. In this set (Fig. 6) it appears that the benchmarks with the highest displacement are represented by the group of RN17-19 and RN26, which are placed near the road adjacent to the area marked as displaced area of debris in figure 2. The characteristic of the site in set 2 (Fig. 6) is overall one described by subsidence with only one bench mark placed in an area with uplift, RN31 (Figs. 2 and 6). Comparing 2017 with 2012 data it appears that the overall trend is of an increasing negative displacement in the majority of the benchmarks, with a few exceptions at the RN26-30 benchmarks with the situation almost reversed.

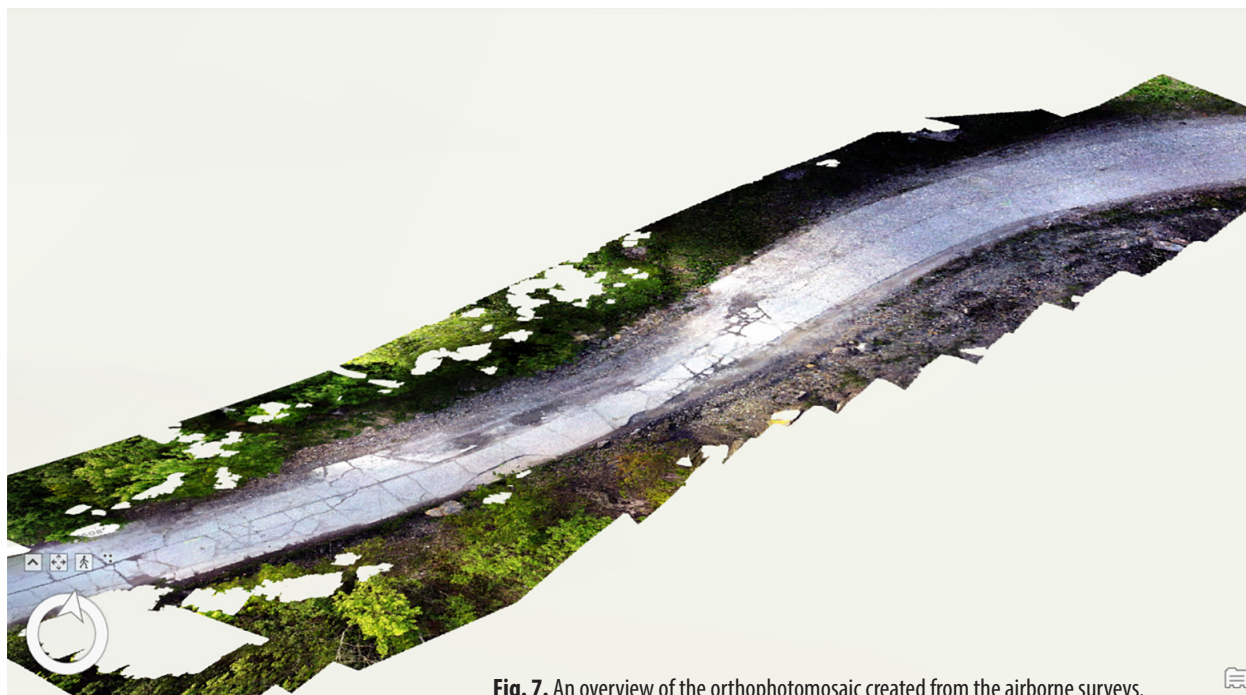
**Fig. 7.** An overview of the orthophotomosaic created from the airborne surveys.

the orthomosaic resulting from the airborne surveys with the drone, visibly highlights a distinctive area in the road where the pavement is significantly damaged (Fig. 7), appearing darker in the data. The orthophotomosaic provides a cm level precision image which allows for a better in depth analysis of the damages created by the active landslide in the area. The darker patch on the side of the road closer to the lake, also shows a slight subsidence as well on top of the significant visible damage, however character changes while following the road more to the east, where the road appears significantly in a better shape. The orthophotomosaic allows for visualising several features like cracks in the pavement for example (Fig. 8), where this crack for example appears to have a spread of approximately 0.15 cm and an elevation change of approximately 4 mm. Information like this is very useful if repetitive surveys are carried out regularly for measuring how much these cracks develop in time and to calculate at what rate these are developing.

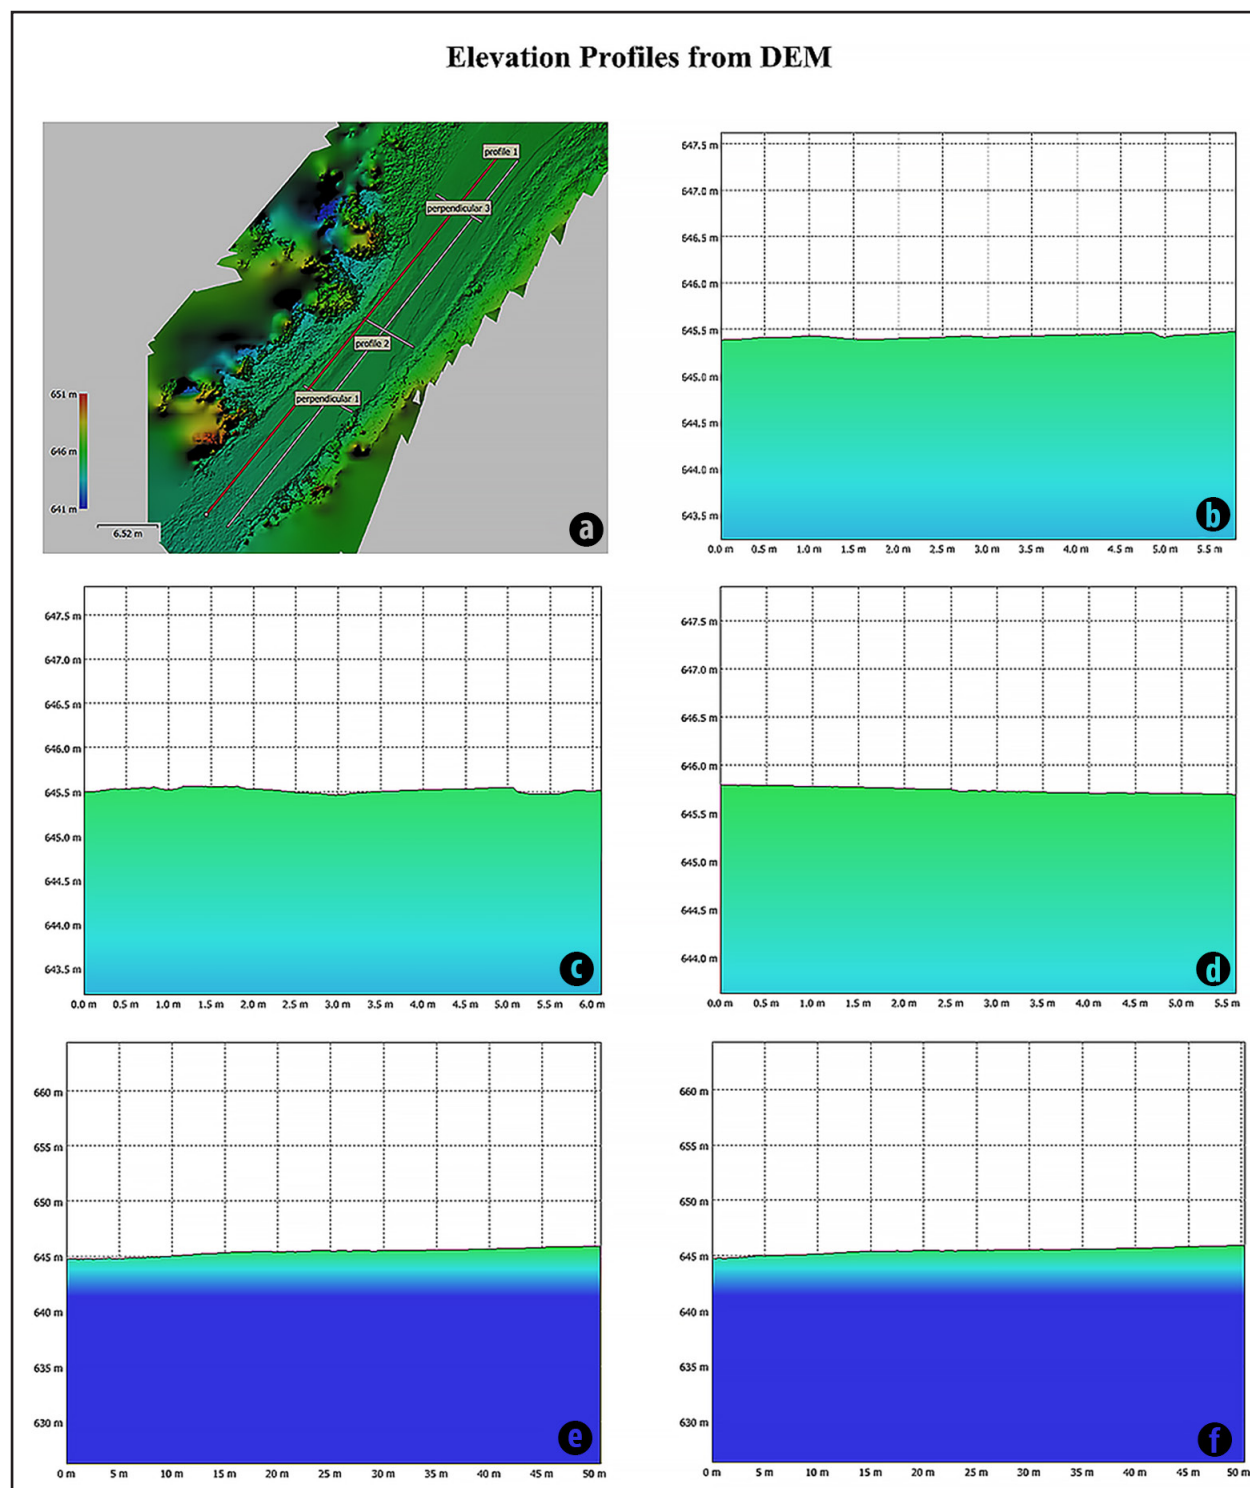
**Fig. 9.** The DTM resulted from the airborne surveys and elevation profiles from different sections with the focus on the deterioration area: (a) overview of the DEM and the elevation profile location; (b) perpendicular profile 1; (c) perpendicular profile 2; (d) perpendicular profile 3; (e) longitudinal profile 1; (f) longitudinal profile 2.

The other set of data resulted from the airborne surveys with the drone, is represented by the DEM's, which allows for a better overview of the different elevation differences in the area and better highlight deformations at the surface which won't be visible to the naked eye. Elevation profiles (Fig. 9) in different areas of the DEM, highlight the difference in elevation throughout the whole data set and surveyed area. This way it is possible to see with a really high precision, the change in elevation across the profile (Fig. 9e-f). In the shorter profiles across the width of the road (Fig. 9b-d) different deformations and variations can be seen of about 10-15 cm running across the profiles, showing irregularities throughout the whole length of the profiles.

All of the profiles and data show slight subsidences appearing in the area closer to the landslide marked in the levelling network figure (Fig. 2), and subsidence in the range of 10 cm in the area which appears darker and visibly appearing with damaged concrete at the surface visible in the orthophotomosaic (Fig. 7).

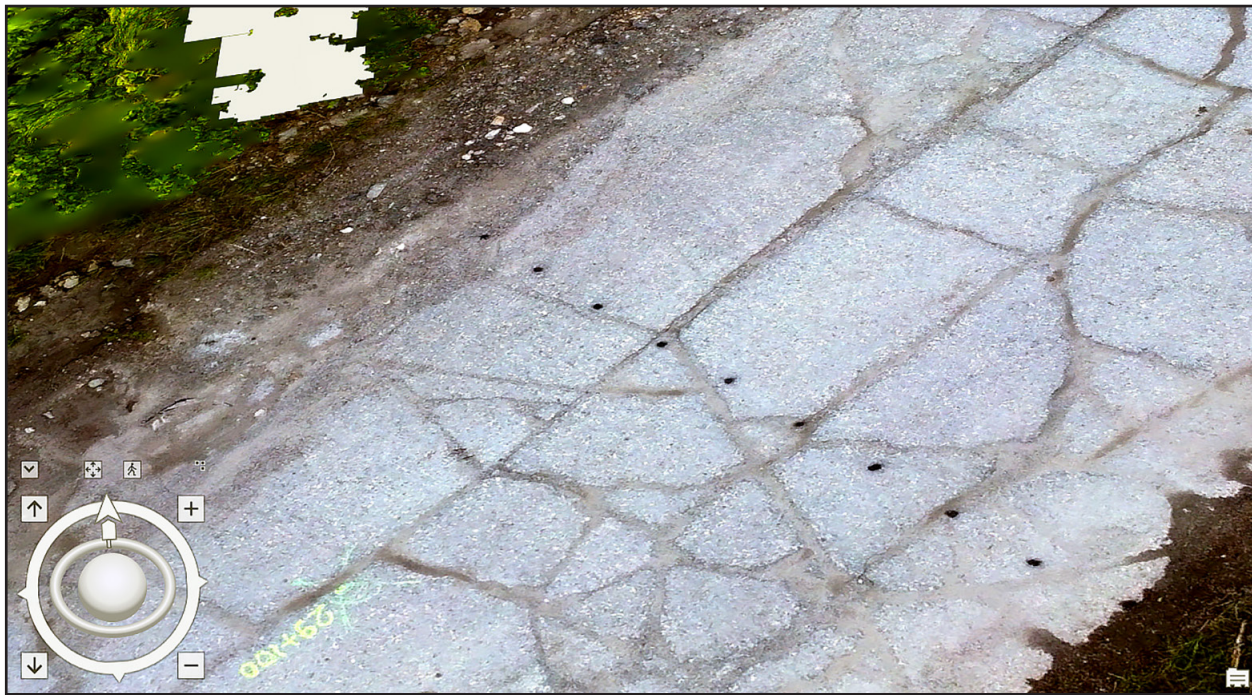
**Fig. 10.** The quality of the orthophotomosaic allows for detecting the end of the GPR profiles marked with spray on the pavement.

Apart from these data, the orthophotomosaic and the DEM, resulted from the airborne surveys with the drone, the survey proved to be very efficient in highlighting the areas

marked with spray at the end of the GPR profiles (Fig. 10). Therefore allowing for a better positioning of the GPR profiles in GIS and allowing for comparing and following areas of interest across all of the methods.
